MODEL STUDY OF C-5A LANDINGS ON AM2 LANDING MAT

Utah State University

# TECHNICAL REPORT NO. AFWL-TR-72-210

August 1973

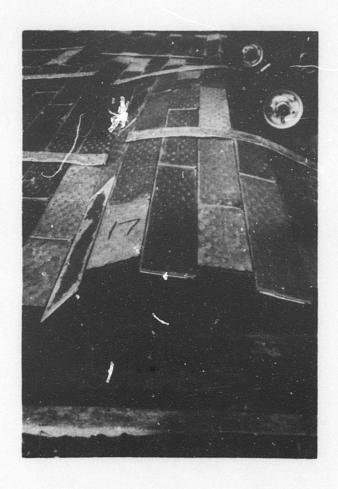
Figure 5.15. Bow Wave Left in the Runway After Failure of the Stiffened Mat.
